Fourth Five-Year Review Report for Pickettville Road Landfill FLD980556351

Jacksonville Duval County, Florida

January 2016

United States Environmental Protection Agency Region 4 Atlanta, Georgia

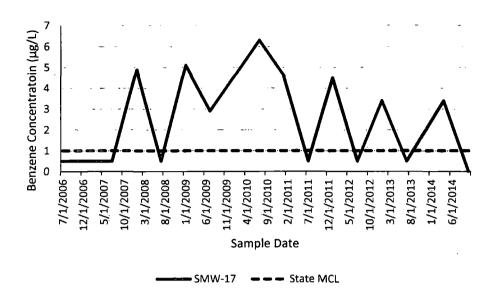
Figure 5: Benzene Concentrations in Upper Sand Aquifer Well SMW-17

The PRPs detected several VOCs (1,1-dichloroethene; 1,1-dichloroethane; chlorobenzene; 1,2-dichloroethene; and benzene), but only benzene was above its MCL. Benzene was above its MCL in SMW-17, but the concentrations were below the ACL of 115 μ g/L, which is protective of surface water. The concentrations fluctuate seasonally but generally decline over time. The concentrations in the previous five years ranged from below detection to 6.3 μ g/L in July 2010; the most recent sample collected in October 2014 was 3.2 μ g/L (Figure 5).

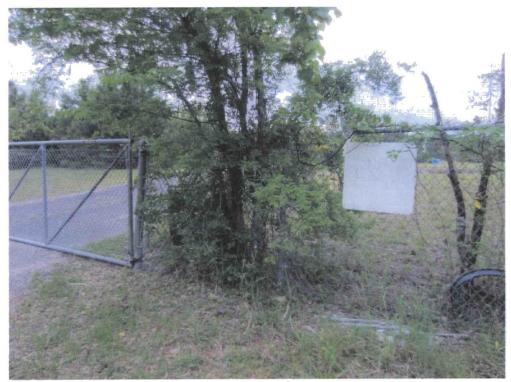
Locked entry gate with illegible warning sign.

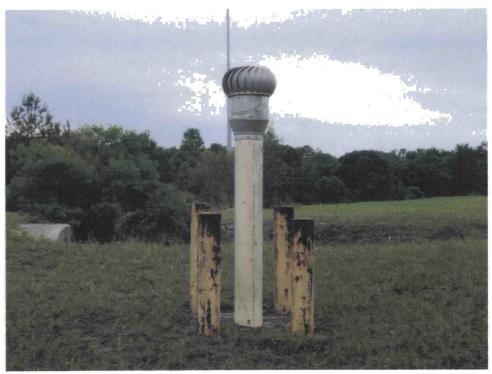
Passive gas vent on the landfill.

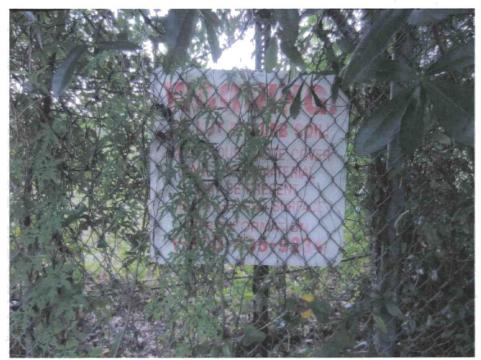
Vegetation blocking sign on perimeter fence.

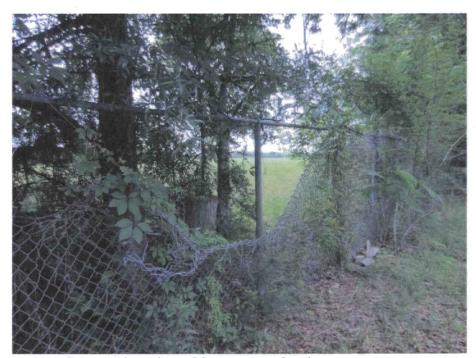
The landfill cover, stormwater management and gas control systems are regularly maintained. The Site is surrounded by fencing to prevent unauthorized access to the Site. However, a portion of the fence has been vandalized to allow trespassing near the main entrance gate along Pickettville Road. In addition, warning signs along Pickettville Road are illegible due to fading or heavy vegetation. Due to the presence of waste left in the landfill, site access controls require repair to ensure trespassers do not disturb the remedy and potentially become exposed to landfill waste. Restoration of Little Sixmile Creek is complete. A final ecological study indicated no ecological impacts from the Site and that further Site restoration was not necessary.

D. Ge	eneral										
1.	Vandalism/Trespassing	o vandalism	n evident								
	Remarks: The fence has been damaged immediately west of the main of	entrance ga	<u>te.</u>

Damaged portion of fence west of main entrance gate.

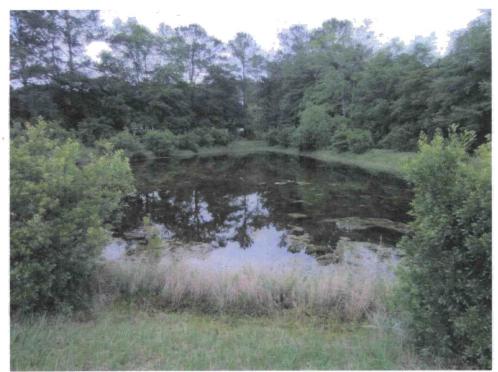
Pond 1 located in the northeast corner of the Site.

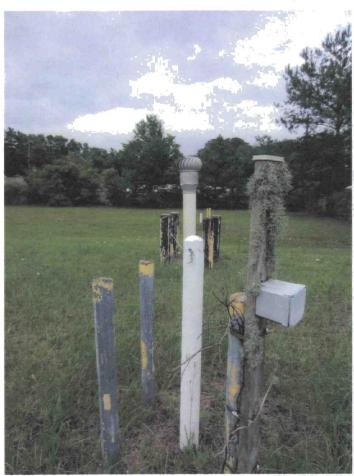
Gas sampling probe in the foreground and passive gas vent in the background.

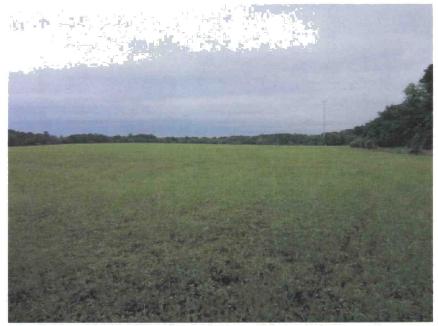
View of landfill surface looking southwest.

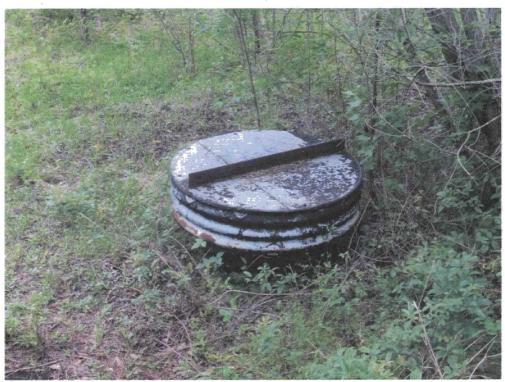
Stormwater 24-inch riser pipe overflow structure located near Pond 2.

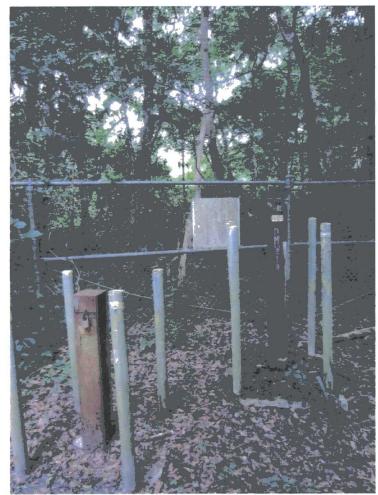
Secured monitoring well cluster 18 (SMW-18 and DMW-18).

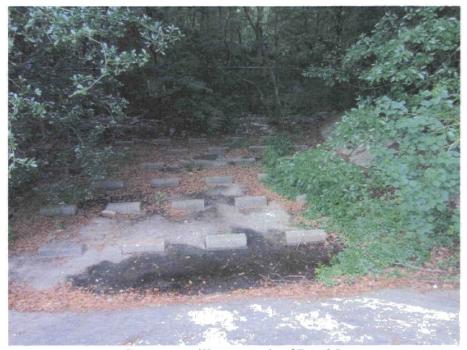
Concrete spillway south of Pond 2.

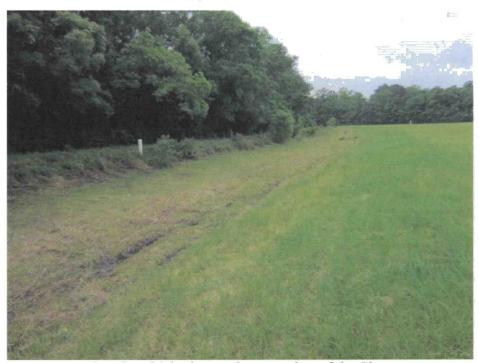
Dry Pond 2 in the southern portion of the Site.

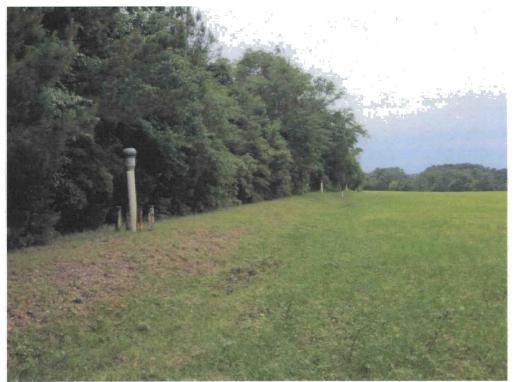
View of the passive gas vents along the southwest perimeter of the Site.

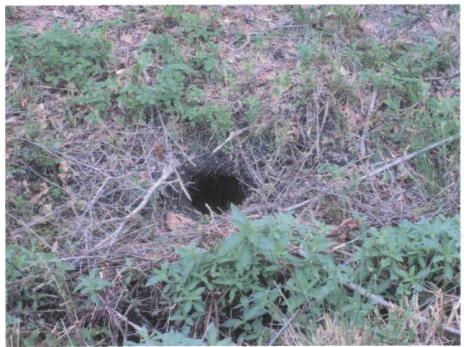
The landfill cover was in good condition with established grass covering the entire surface. Several shallow animal burrows were visible at depths less than 2 feet, which did not penetrate the cap. No trees or shrubs were observed on the landfill. A larger burrow was observed near the southwest perimeter of the Site, outside the landfill. All monitoring wells were in good condition and were secured with padlocks. Passive gas vents were in working condition. The cover was mowed and surface drainage features appeared clear of debris.

4.	Holes	Location shown on site map	Holes not evident
	Arial extent: Several burro	ws were observed on site	Depth: Less than 2 feet in depth
		nimals try and burrow as there were sponly one larger burrow was observed that adfill cap.

Burrow along the southwest perimeter of the Site but not in the landfill.

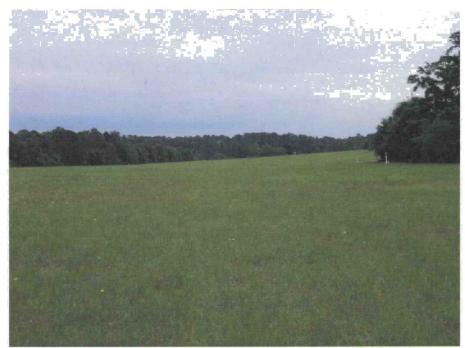
View of landfill cover looking east.

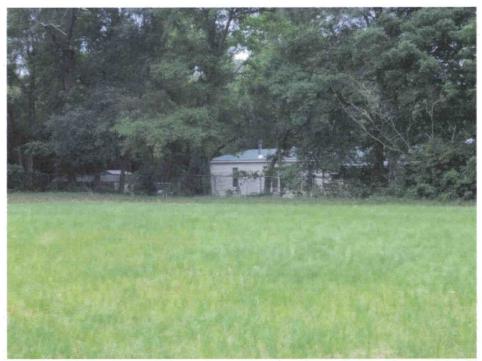
View of residence located along the western border and upgradient of the Site.
